Manhole Inspection Summary

Manhole # S53O__018MH

Insp Date: **12/23/08 12:14 PM**

Location Address: **rear 1102 s clinton st**

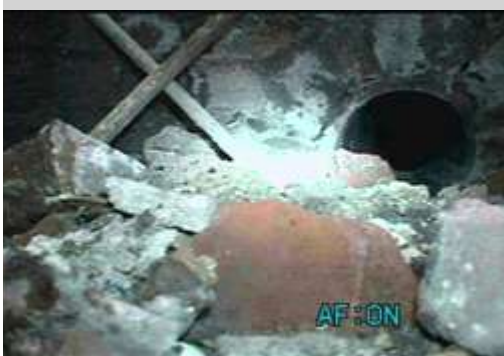
Defect 3

Condition: ☐ Sound ☐ Cracked ☐ Root Intrusion ☐ Deteriorated ☐ Leaks ☒ **Debris**

channel debris

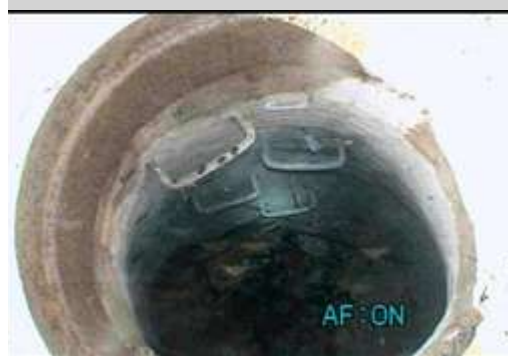
Defect 2

Steps Count: **4** Missing: **0** ☒ **Corroded**

corr steps

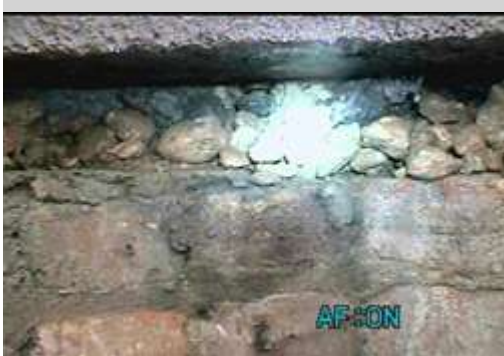
Defect 1

Frame Offset: **0** (in.) Condition: ☐ Sound ☐ Cracked ☒ **Leaks**

Condition: ☐ Sound ☐ Cracked ☐ Root Intrusion ☒ **Loose Brick** ☒ **Deteriorated**

chimney loose bricks and deteriorated,
frame leaks
